# A Christmas nightmare

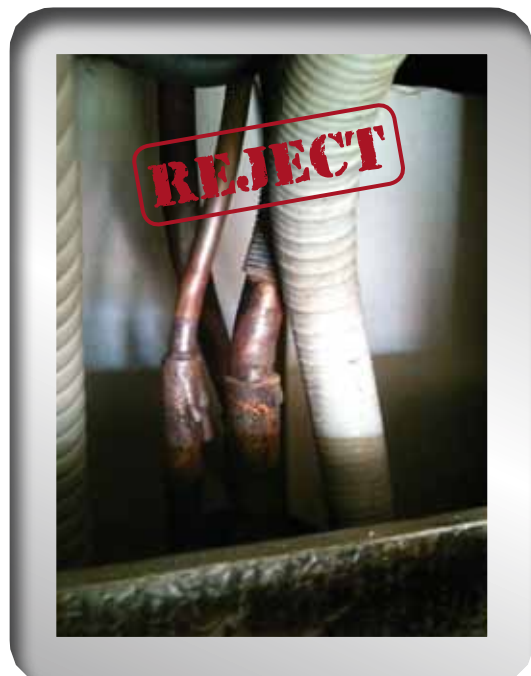
*Different copper pipe sizing just slotted into each other and welded.*

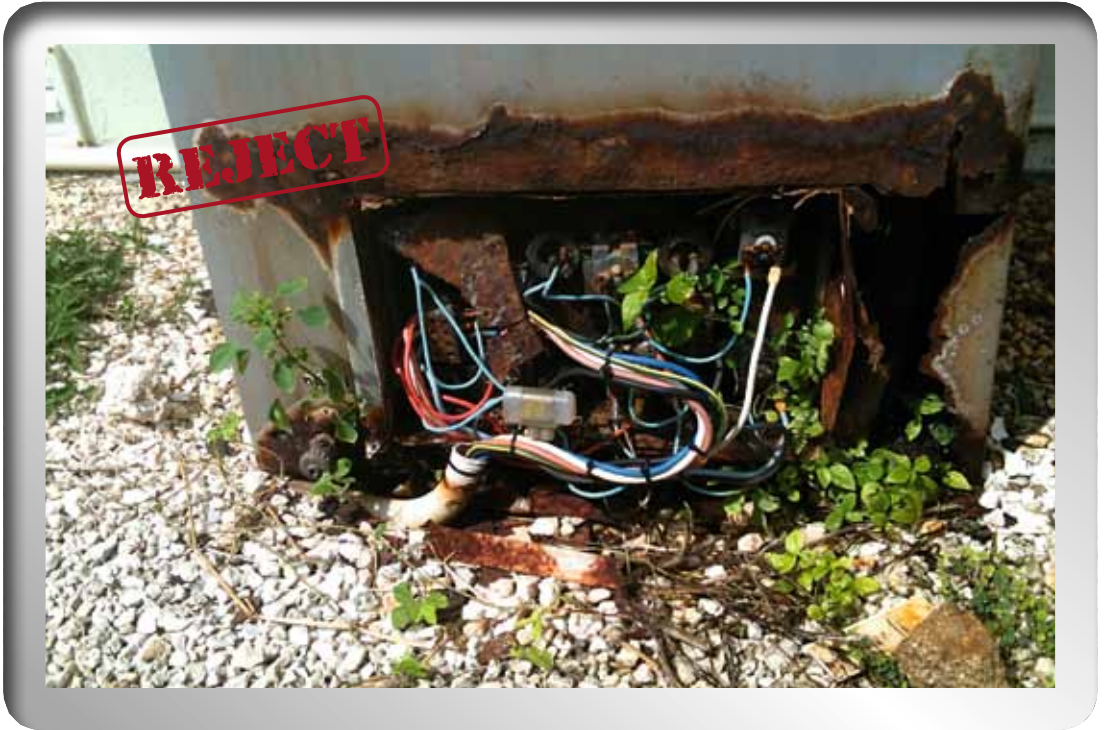
*Exposed wiring.*

- Crushed wires against chassis
- Live wires with no junction box or cover
- Earth, neutral and active wires incorrectly coloured
- Single insulated wires in ceiling spaces with no junction boxes
- Cables not terminated correctly, but rather twisted together
- Insulation not replaced at junctions
- Cables and junction boxes not weather proofed
- No pressure tests of dry nitrogen (done with R410a apparently)
- Copper rated to R22 only, not R410a
- Different copper pipe sizes (ie 3/8" into 1/2") slotted into each other and welded
- Some units had leaked all their refrigerant
- Some old refrigerant cylinders were full and some 10 years out of date
- No isolators installed.

“Why don’t you just cut the cable and re-terminate it? It’s so simple – that’s what I did. Why get a tiny bit of extension lead to join up the air conditioner 250mm when you just pull the cable through 250mm and terminate it straight into the air conditioner. Whoever it was just didn’t have a clue.”

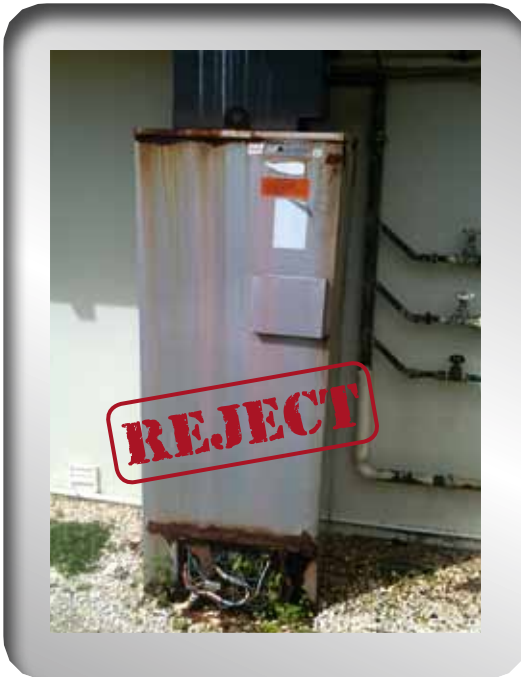
*Corroded hot water units.*

"For the last 12 years, this resort has sat there doing absolutely nothing," he explains. "Most of the buildings are metres away from the sea, and the whole place is just completely dilapidated. There are 200 and 300 kilowatt chillers there that are just falling apart."

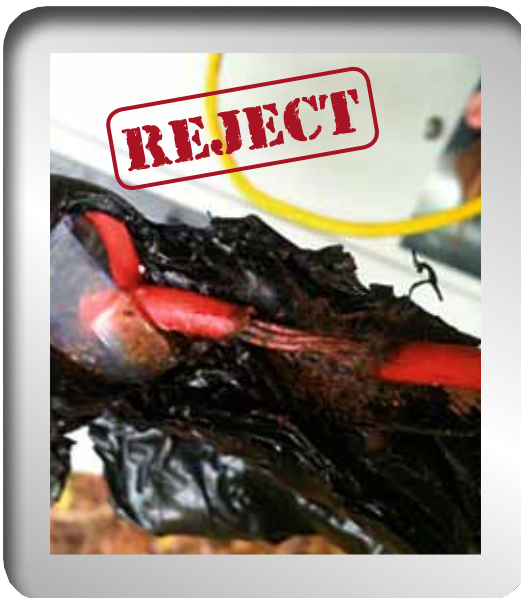
*Sub-standard wiring.*

“There’s no way they [the installer] didn’t know this work was sub-standard, and perhaps it has come about because he didn’t have junction boxes, and didn’t have connectors,” he says, “but you don’t just twist cables and put a bit of tape around them.
